SILVERTON MILL: Case Study

Customer:
DS Smith
Contract Value: £9M

Executive Summary

Award winning regeneration project encompassing the formation of a new river channel, flood defense works, and ecological formation and biodiversity enhancements at a former paper mill.

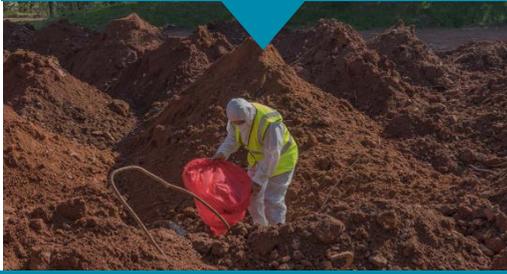
Industrial Legacy

THE FORMER PAPER MILL SITE HAD A HEAVY INDUSTRIAL LEGACY DATING BACK TO THE 1800'S

The former paper mill site had a heavy industrial legacy dating back to the 1800's, which had resulted in a harsh industrial landscape and negative visual impact. In addition to the adverse impact the site had on the local ecology, the site was contaminated with significant petroleum hydrocarbons. The contaminants were present alongside and below the culverted watercourse.

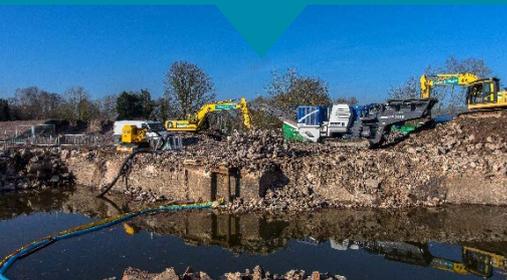
Petroleum Hydrocarbons

CONTAMINANTS WERE PRESENT ALONGSIDE AND BELOW THE CULVERTED WATERCOURSE

Petroleum hydrocarbon impacted soils were excavated from the areas adjacent to the former culvert structures. Work was carried out under a Materials Management Plan (CL:AIRE Definition of Waste: Development Industry Code of Practice).

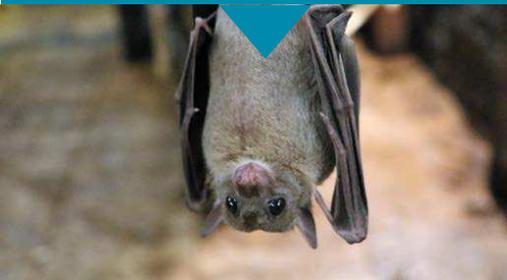
Local Ecology

ECOLOGICAL SURVEYS UNDERTAKEN IDENTIFIED MATERNITY ROOSTS FOR DAUBENTON'S BATS WITHIN THE CULVERT, AND BROWN LONG-EARED BATS WITHIN THE MILL STRUCTURE

Ecological surveys undertaken prior to the commencement of the works identified maternity roosts for Daubenton's bats within a small section of culvert, and Brown Long-Eared bats within the mill structure itself. Whilst sensitive species such as reptiles and aquatic animals were not identified in significant numbers, care was required to avoid any potential negative impacts on all wildlife throughout the works.

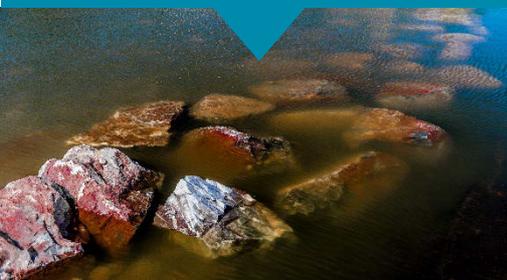
Flood Defences

THE TRANSFORMATION OF THE LARGE CULVERTED SECTION OF THE RIVER CULM INTO AN ATTRACTIVE RIVER CORRIDOR WAS NECESSARY TO IMPROVE FLOOD DEFENCES

The transformation of the large culverted section of the River Culm into a diverse and attractive river corridor was necessary to improve flood defences; as part of this the range of river and wildlife habitats introduced as part of the project also helped to enrich biodiversity.

The design of the newly created river channel required that an oversized, predominantly over-wide profile would be constructed, allowing some degree of natural freedom for the river to find a stable regime. The sizing of the newly created channel was determined by the width of the natural undisturbed channel upstream and downstream of the work area, along with the estimation of open channel flow rates.

The river base was constructed as close to natural width as possible, but with gentle sloping banks to create a significantly widened flood stage channel. The over widening of the channel at flood levels was designed to reduce velocities and hence erosion pressure; these were important considerations with respect to long-term integrity of the 600mm clay liner, prevention of contaminant to the river, whilst ensuring that the newly placed artificial upper 'benthic' layer would not be prone to erosion.
